BRADWAY DAM

CT 00480

PHASE I INSPECTION REPORT  
NATIONAL DAM INSPECTION PROGRAM

Identification No:	CT 00480
Name of Dam:	Bradway Dam
Town:	Stafford
County and State:	Tolland, Connecticut
Stream:	Unnamed
Date of Inspection:	17, February, 1981

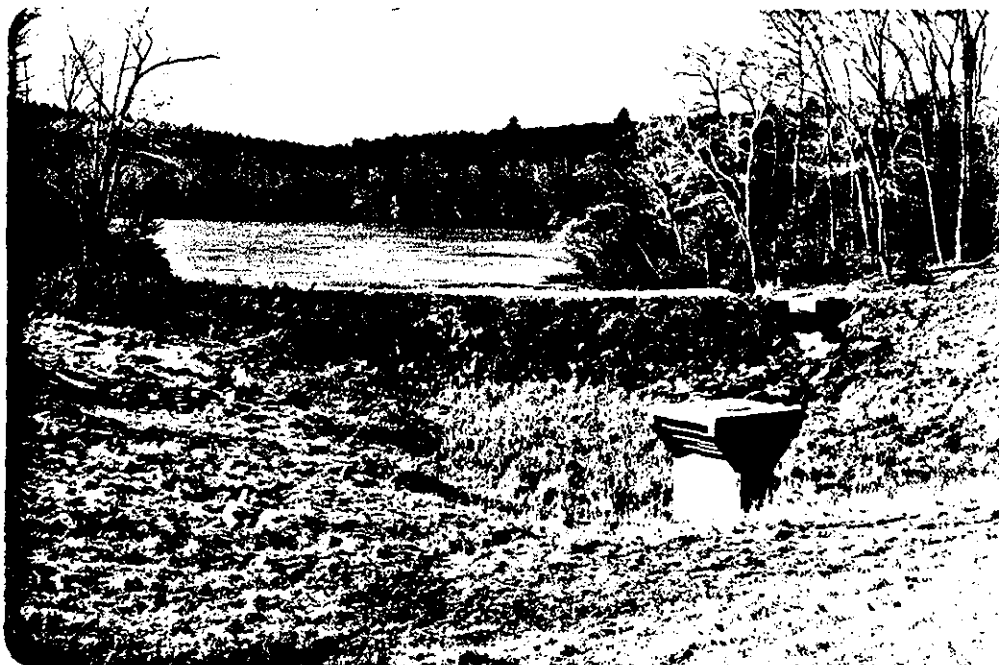
C-2 UPSTREAM SLOPE

1. Upstream Face - The upstream face is grass covered with a very dense mat on most of the surface. There are no trees growing on this slope which is shown in Photo No. C-2.
2. Crest - The crest is grass covered. It is relatively level with vehicle tracks, but no significant rutting.
3. Downstream Face - The downstream face is grass covered with a very dense mat and is shown in Photo No. C-3. The foundation drains appear to be functioning with minor flow at the time of the inspection. Outlets to the foundation drains are shown in Photo No. C-5.

- d. Reservoir Area About 100 feet upstream of the dam there is an existing pond with a 6-foot high earth dam and concrete spillway as shown in Photo No. C-2. The area flooded by Bradway Dam other than the existing pond is a swampy area to the south of the pond and north of Sandy Beach Road (Conn. Route 140).

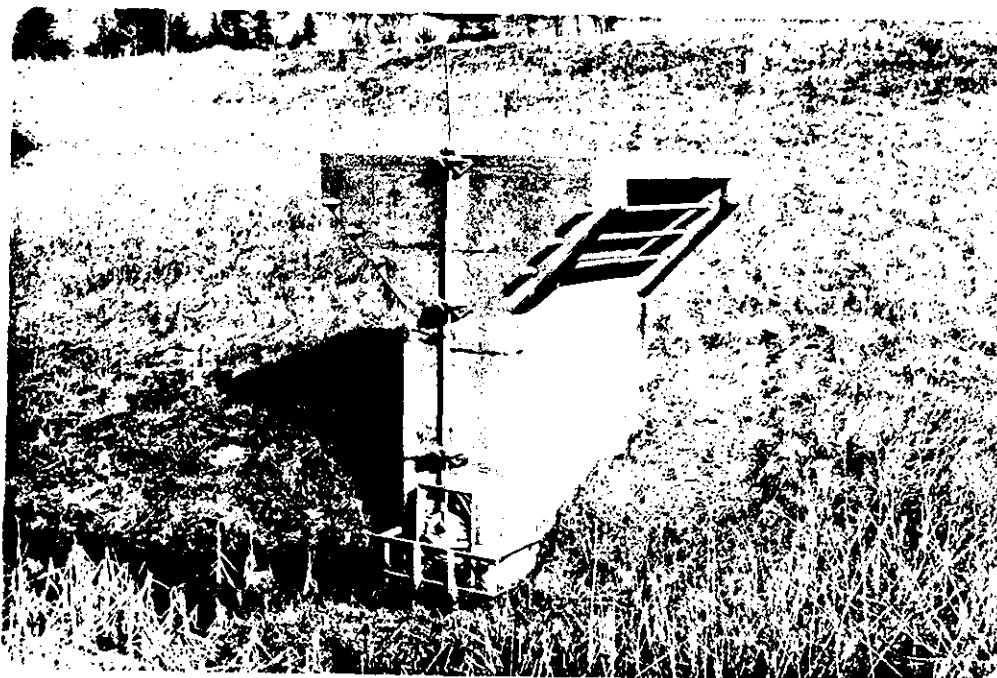
C-4 PRINCIPAL SPILLWAY INLET STRUCTURE

1. Principal Spillway - The inlet to the principal spillway is shown in Photo No. C-4.

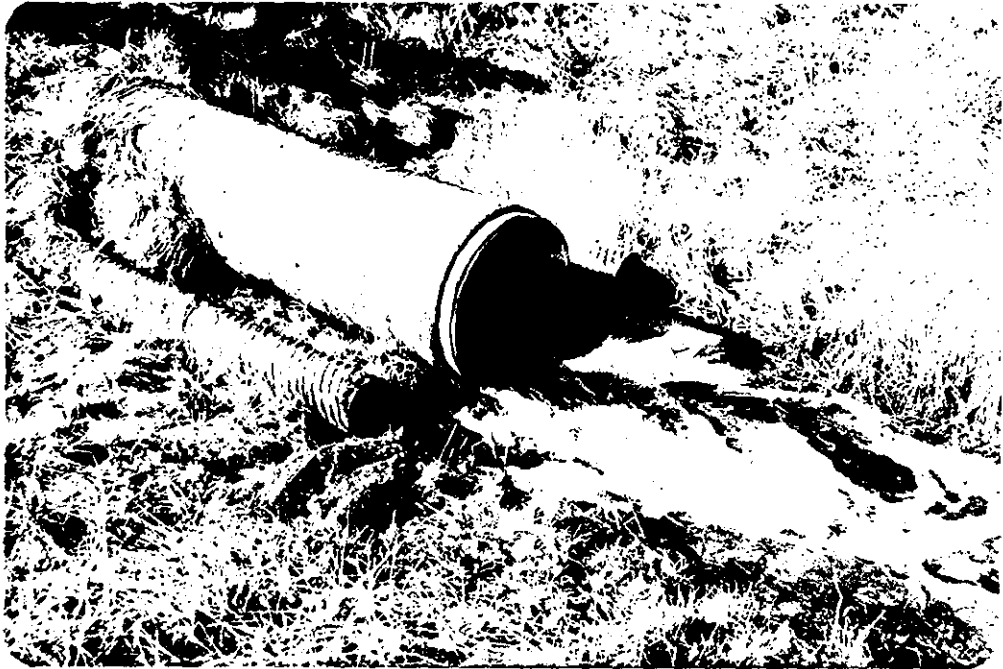
C-5 PRINCIPAL SPILLWAY OUTLET

The pipe from the riser through the embankment to the outlet is a 24-inch reinforced concrete water pipe. The portion of the pipe that is visible is in good condition and is shown in Photo No. C-5.

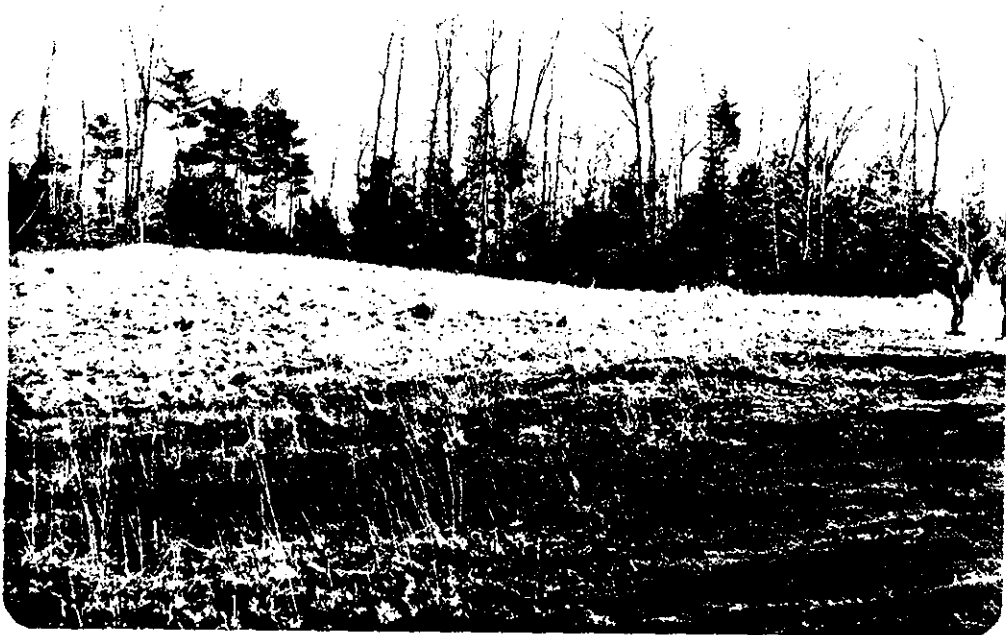
C-6 EMERGENCY SPILLWAY

2. Emergency Spillway - The emergency spillway is grass lined and is a natural channel northwest of the dam as shown in Photo No. C-6. There is a good mat of grass and the spillway is in good condition.
